JPL D-18441

Report on the Loss of the Mars Climate Orbiter Mission

JPL Special Review Board

November 11, 1999

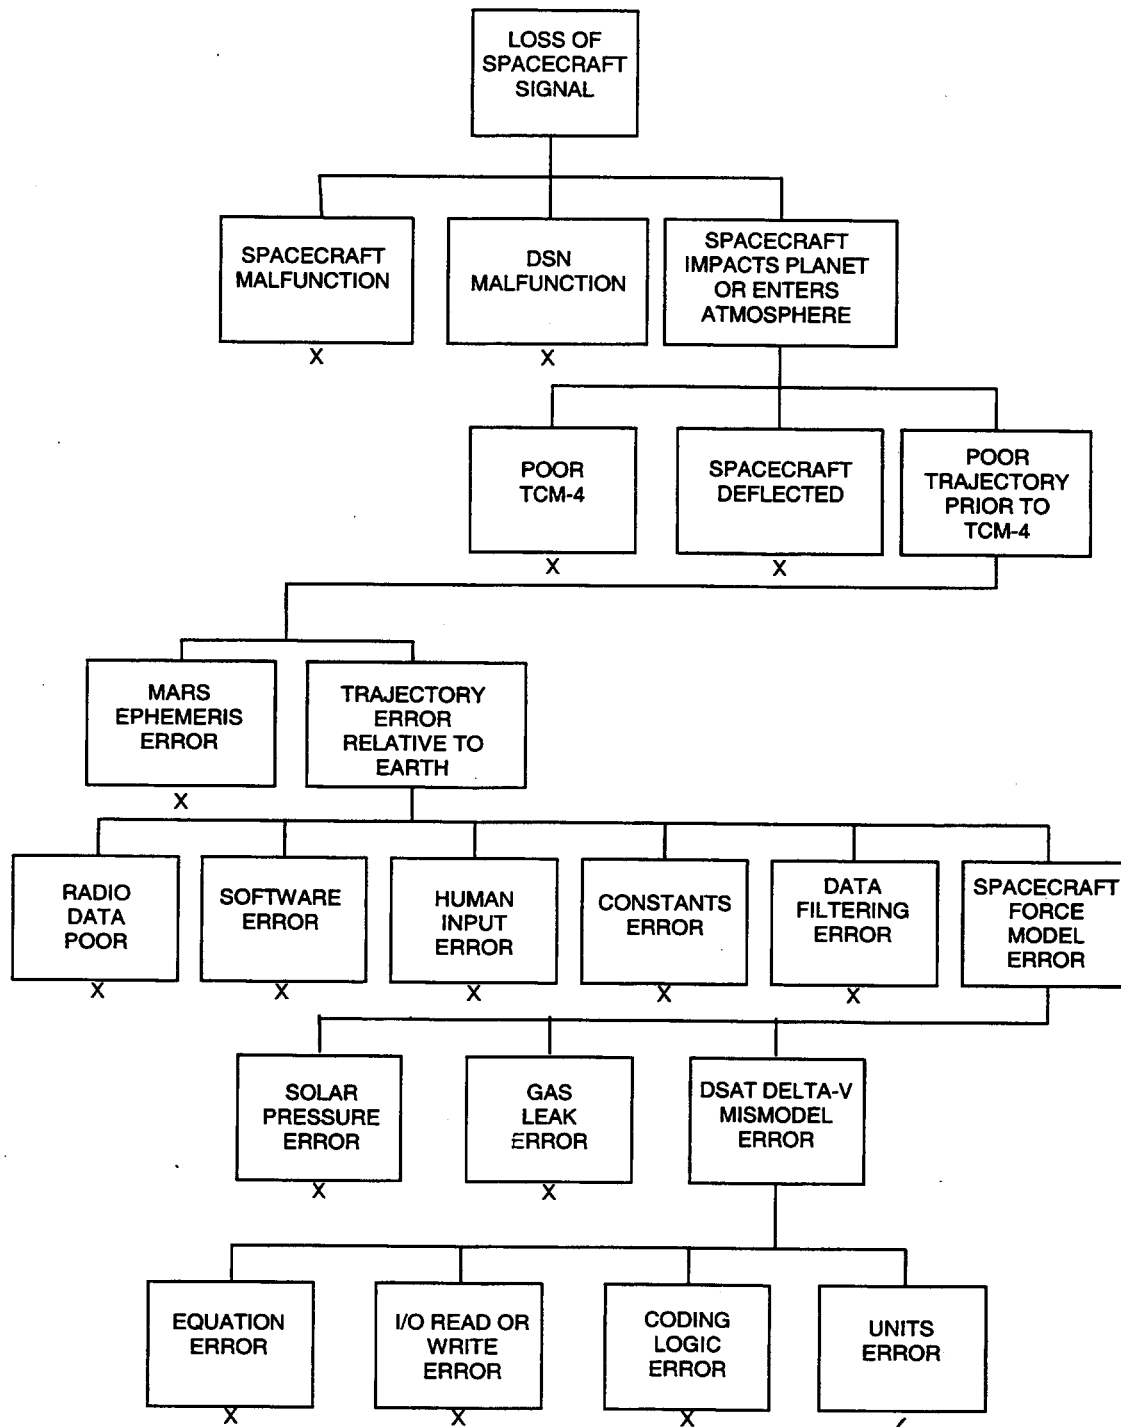
Figure 1: MCO Loss-Of-Signal Truncated Fault Tree Diagram

- The loss of mission occurred when the MCO entered the Martian atmosphere (see the Note below).
- The MCO entered the Martian atmosphere because the spacecraft approached at an incorrect trajectory.
- The trajectory error was caused by errors in small forces modeling.
- The modeling error occurred because small forces information was delivered in pounds-force seconds, instead of the required Newton-seconds.

Figure 1 is a truncated fault tree of the possible causes of the loss of signal. The fault tree is truncated to exclude root error sources for those areas that the team had ruled out as possible contributors to the mishap.

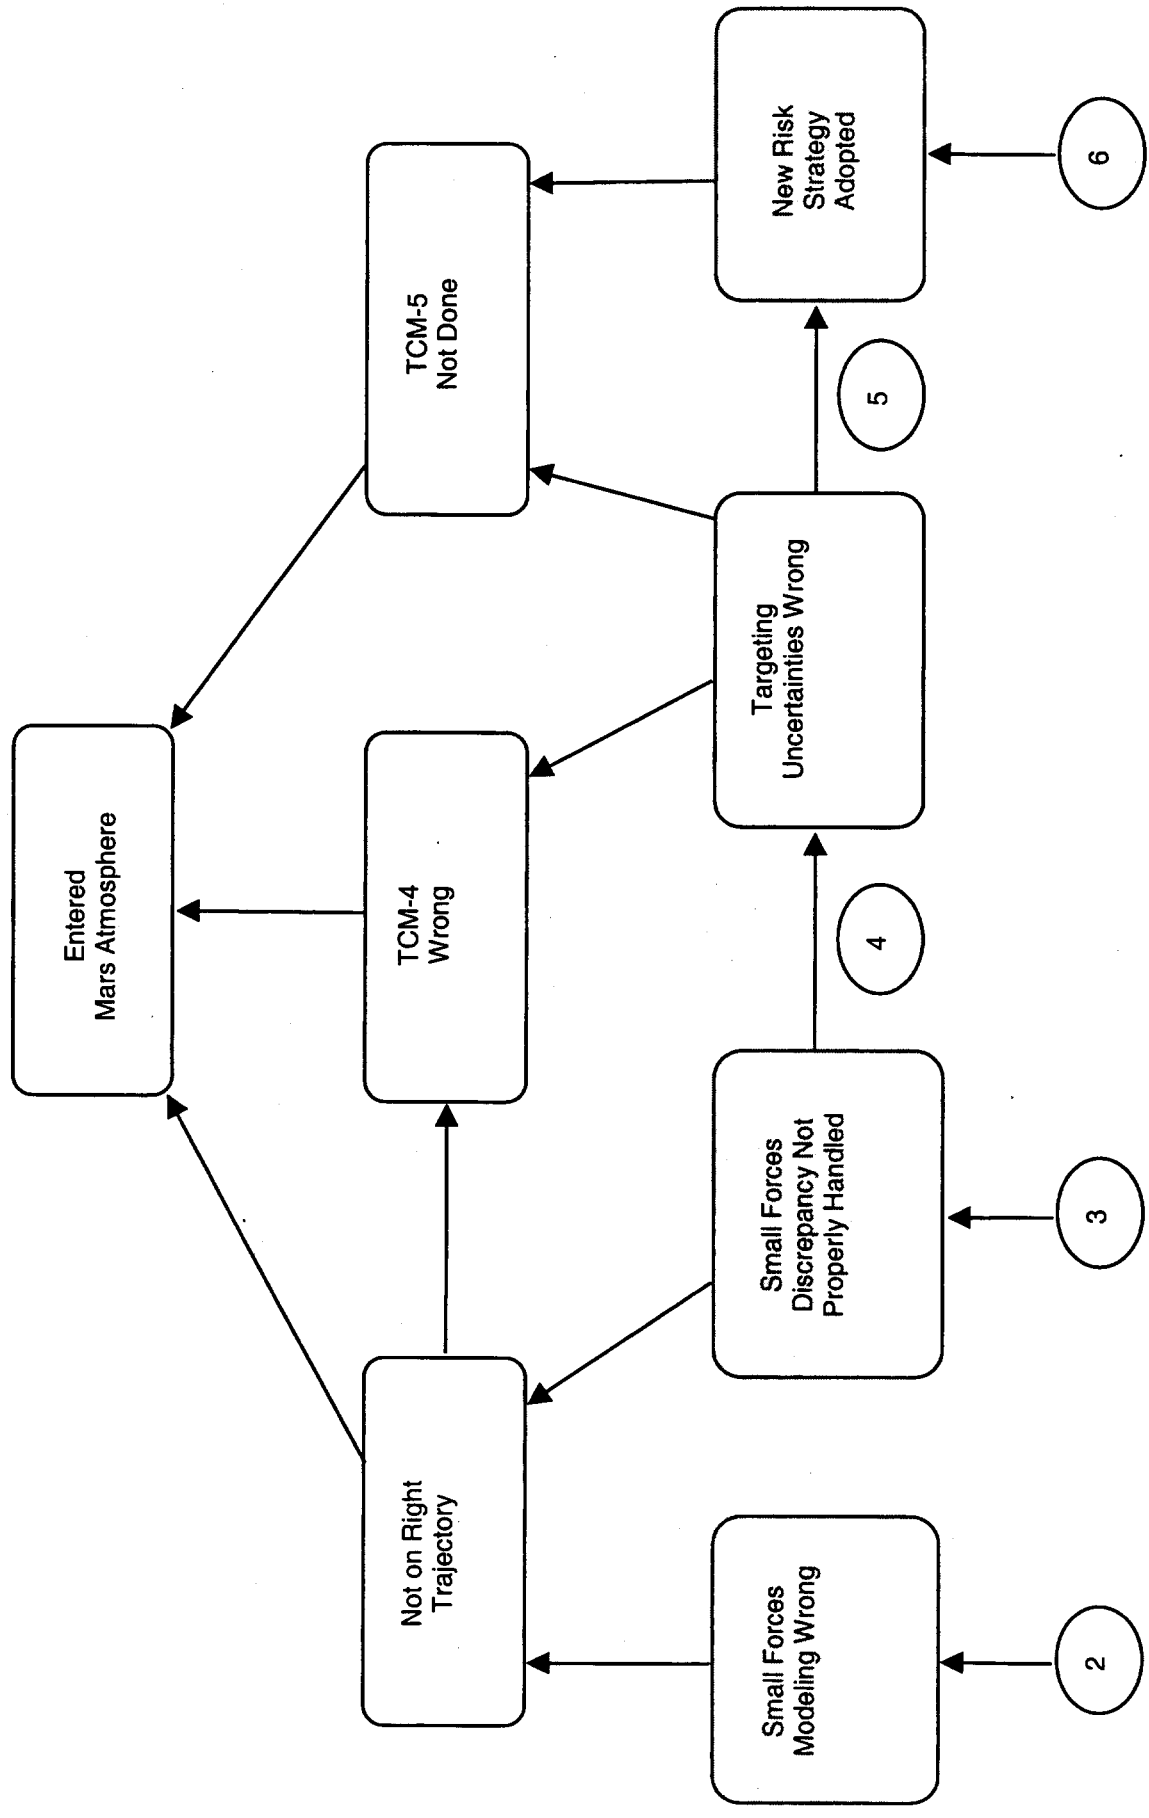
Figure 2: Reasons That The MCO Entered The Atmosphere

The results of this analysis are presented graphically in Figures 2 through 11, which begin on page 7. Each box in these Figures represents either an event or the absence of an event that contributed to the loss. The organization of the charts is hierarchical. For example, the top box on Figure 2, labeled "Entered Mars Atmosphere", represents the loss of mission statement. The figure shows three causative factors:

- The spacecraft was on the wrong trajectory,
- The fourth trajectory correction maneuver (TCM-4) was wrong,
- The contingency maneuver (TCM-5) was not performed.

These are the reasons why the MCO entered the Mars atmosphere. Each of these three boxes, in turn, has arrows pointing to them that represent contributing factors.

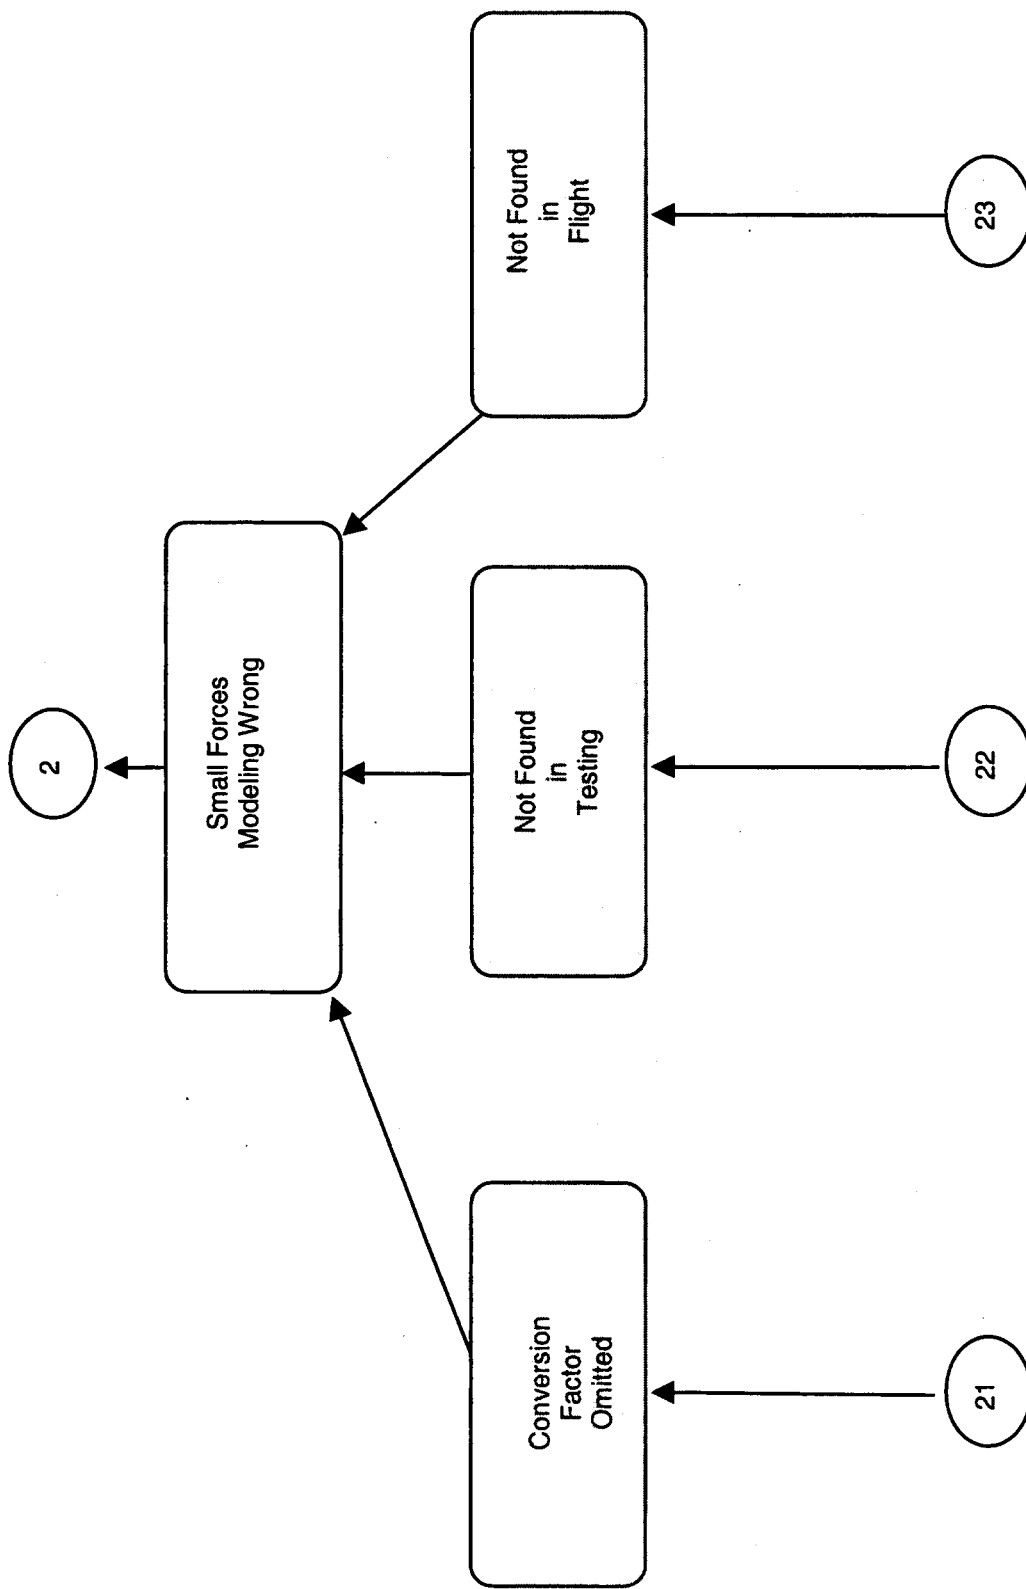
Figure 3: Reasons That The Small Forces Modeling Was Wrong

The MCO was on the wrong trajectory because the MCO navigation process did not correctly account for the small forces acting on the spacecraft.

Two separate but related factors contributed to the error in small forces modeling:

- The omission of the English-to-metric conversion factor in the software program used to generate the AMD files.
- The LMA software program used to generate the AMD file also incorrectly formatted the data on the files, rendering the files unreadable by the navigation software. The format problem was not corrected until mid-April 1999, with the result that the small forces inconsistency was not uncovered until more than four months after launch.

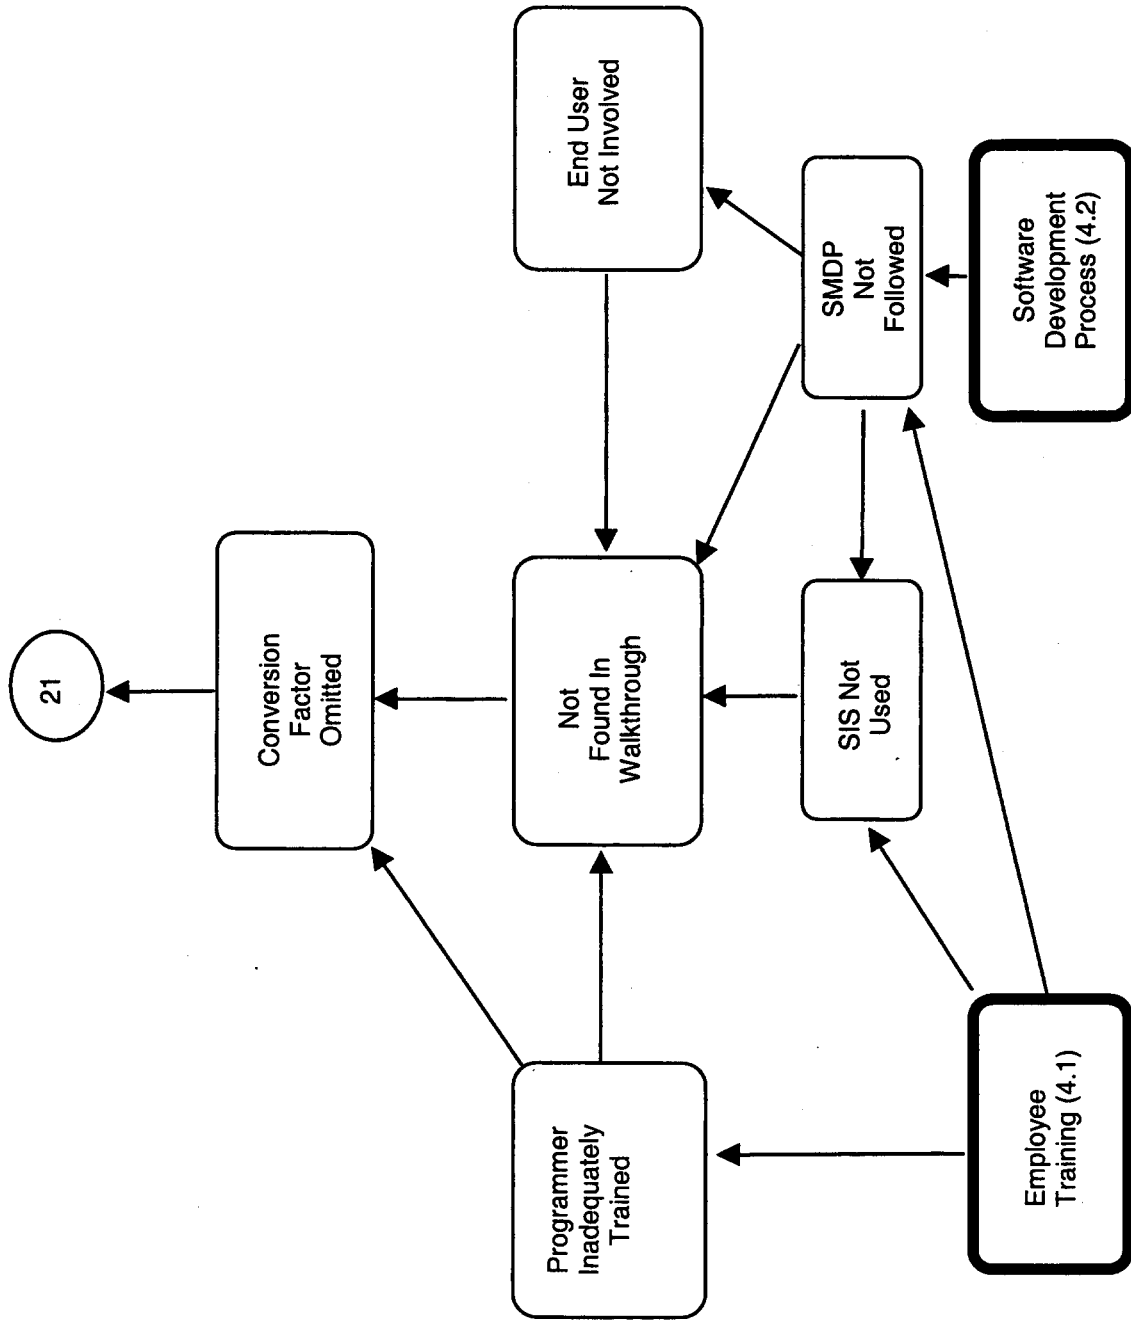
Figure 4: Reasons That The Conversion Factor Was Omitted

The reasons why the small forces modeling was wrong and remained undetected, either in the pre-launch development phase or in the operations phase, are illustrated in Figures 4, 5, and 6.

LMA did not follow their Software Management and Development Plan (SMDP) in the development of the Sm_forces software program. Specifically, required persons were not in attendance at the walkthroughs and the Software Interface Specification (SIS) was not used in the walkthroughs. Also contrary to the SMDP, there were no minutes of the walkthrough meetings, action items from the review were not published, and the interface with navigation software was not tested. Further, there was inadequate training of software and other project personnel in the software walkthrough process.

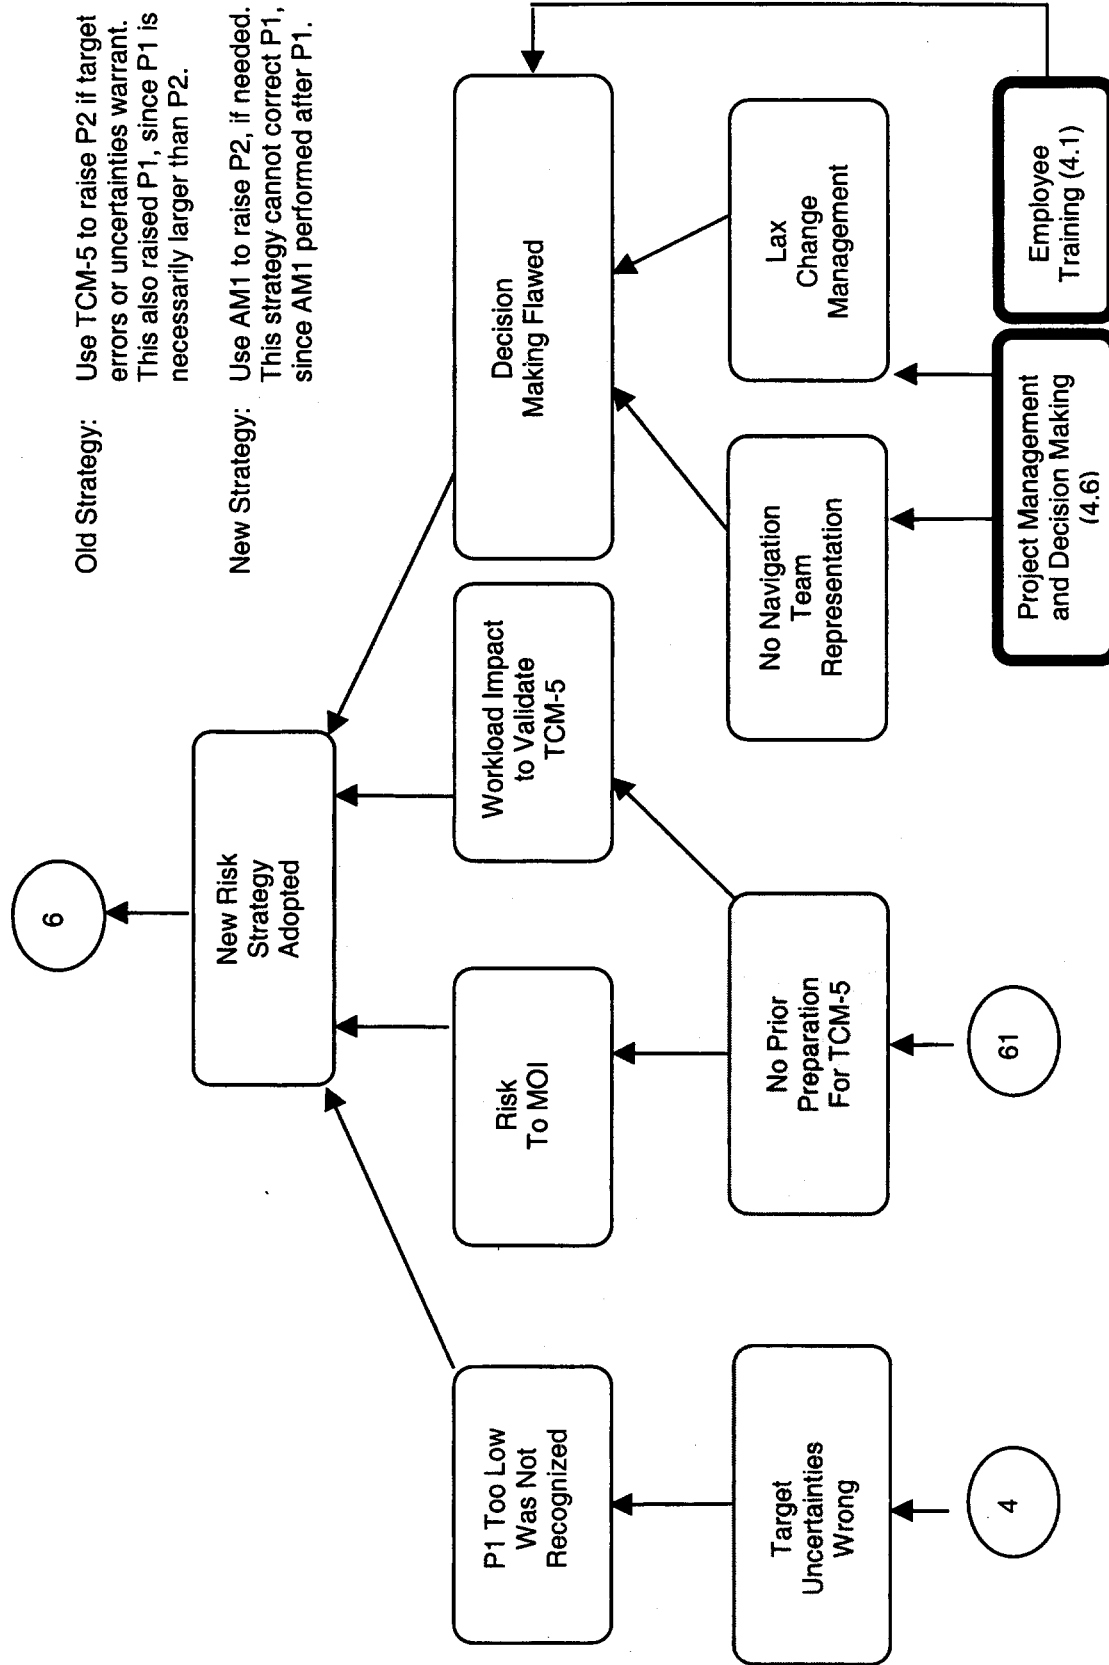
Figure 10: Reasons That The New Risk Strategy Was Adopted

The third causative factor was the decision not to execute TCM-5. The mission plan called for the execution of a fifth contingency maneuver (TCM-5) in case of trajectory errors following TCM-4. However, this maneuver was never executed. In spite of anomalous orbit determination results following TCM-4, the mission managers decided not to execute TCM-5, the risk-reduction contingency maneuver. Again, a major factor in this decision was project management's lack of knowledge of the true trajectory uncertainty. The other major factor in deciding not to execute TCM-5 was project management's decision to change the baseline risk-management strategy in the days immediately preceding Mars orbit insertion. Appendix 5 discusses the issues relating to changing the risk management strategy after TCM-4.

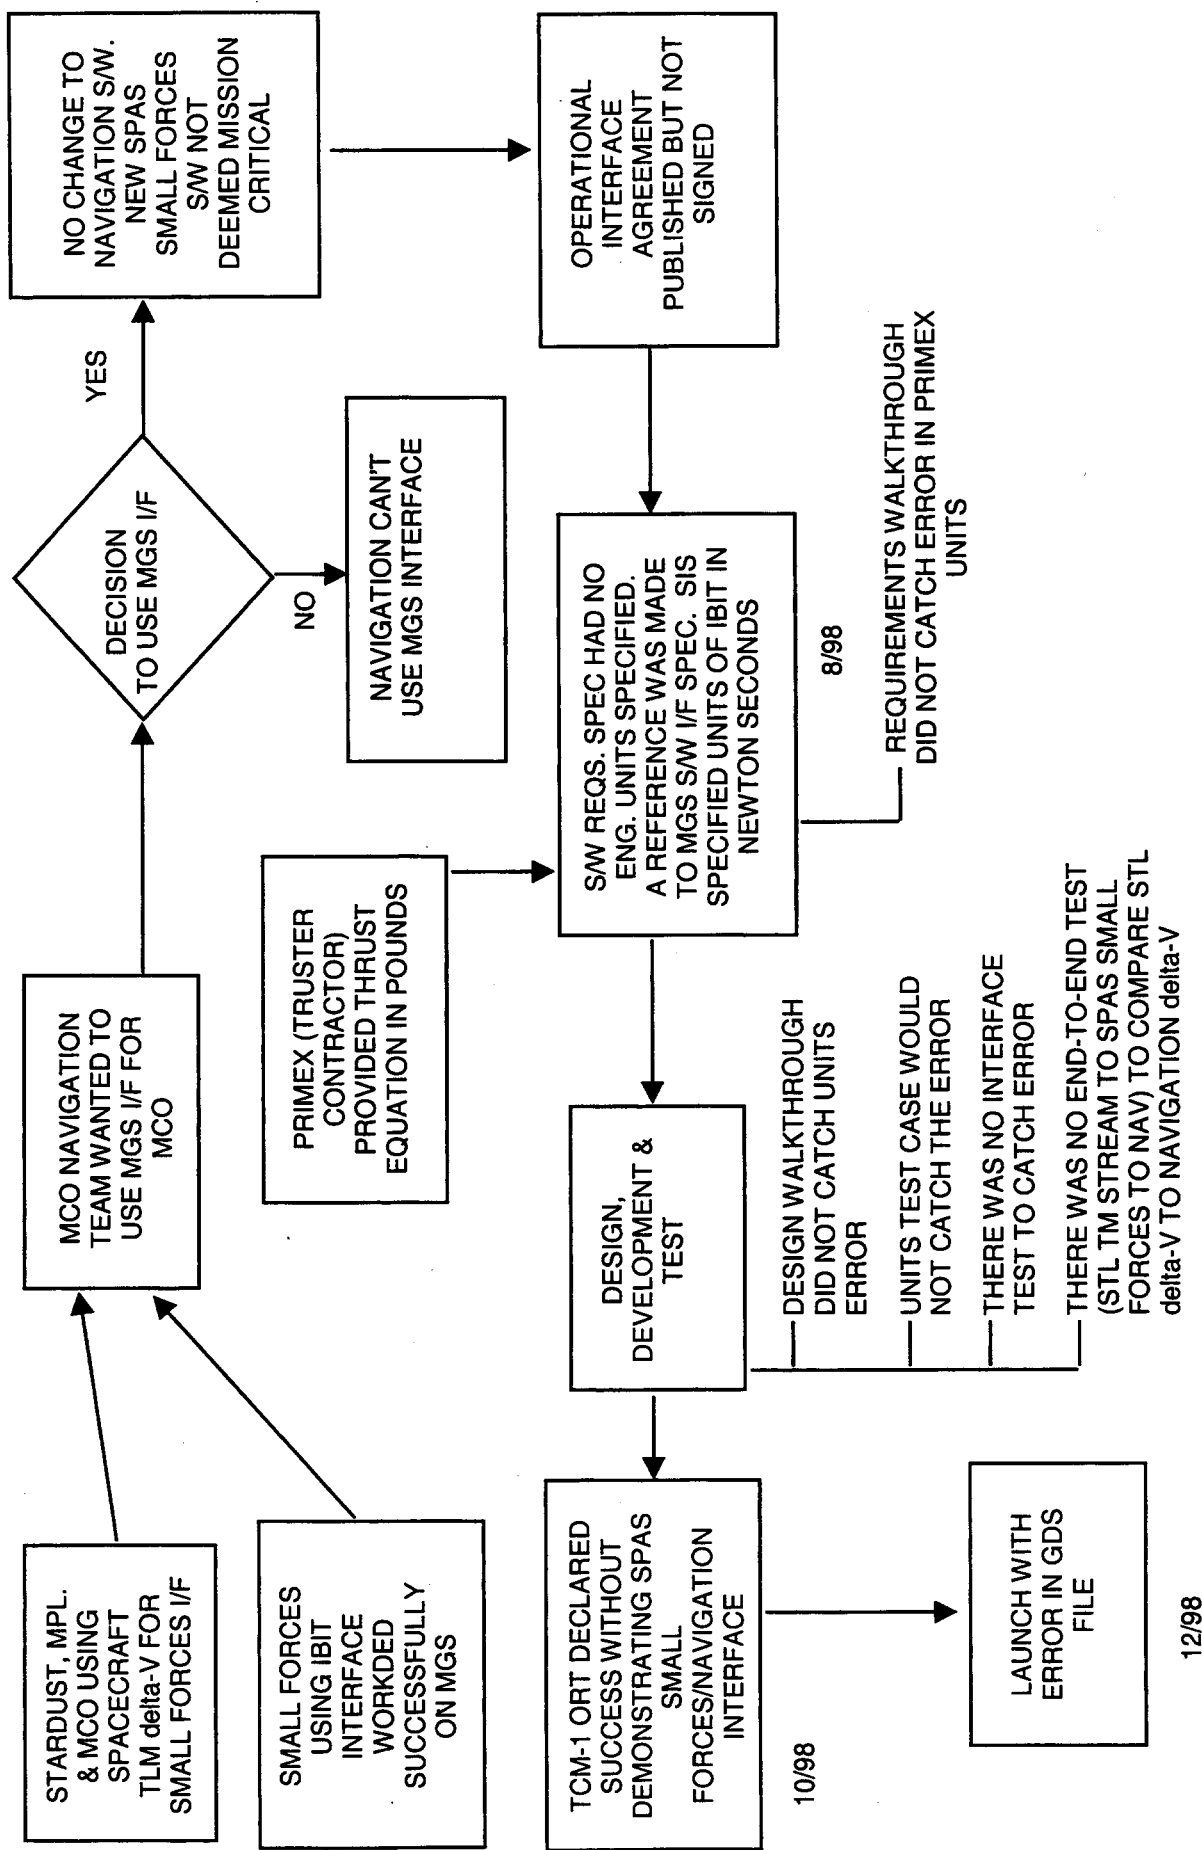
Figure 12: Units Error Events

The spacecraft launched with the error in units still in the system.

Figure 12 is a flow diagram of the events described in this section.

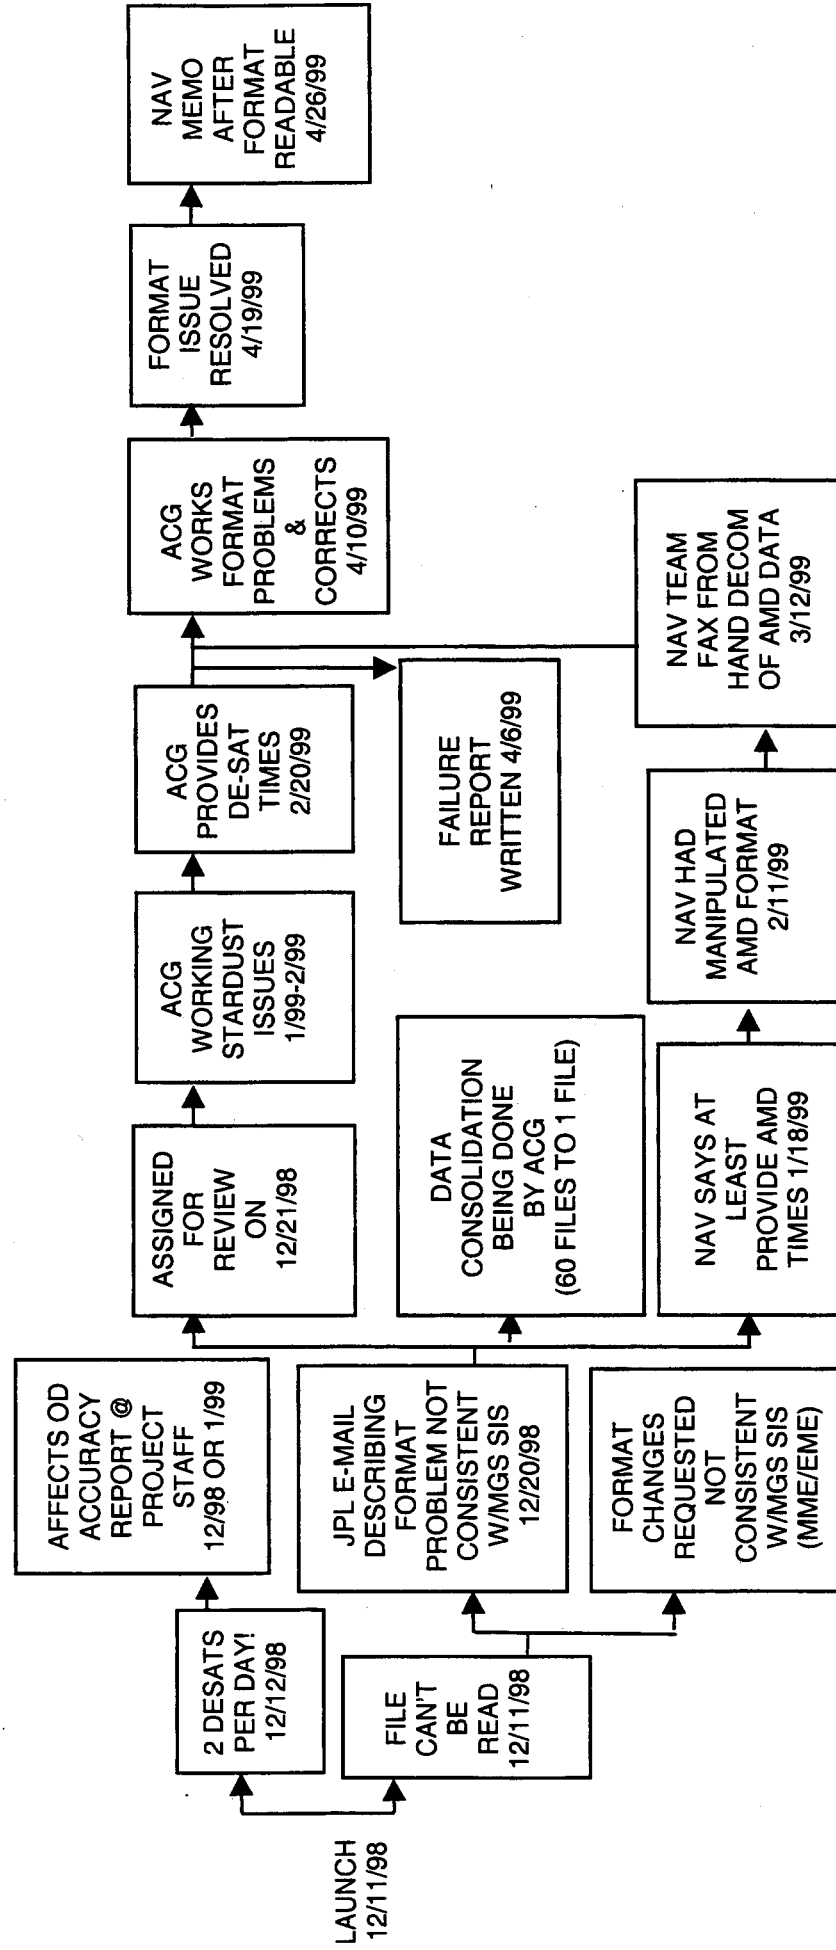
Figure 13: AMD Format Problem

At that time, it was also noted that there were 2 desaturations per day. Although the number of desaturations was in accordance with the predicted spacecraft performance, the number of desaturations was a complete surprise to the Navigation Team. In addition, there were approximately 60 AMD files per desaturation maneuver. It is clear there was no valid interface testing for the AMD files during the launch readiness test. The 60 or so files resulted from the desaturation maneuver strategy. Rather than one long firing, a short burn was implemented during each computer cycle. Each short firing was encapsulated into a separate file.

Knowing the Stardust attitude issues, JPL requested that, at least, the times of the desaturations events be provided. Knowing the times of the desaturation events, even if the magnitudes and directions were not known, would be an aid to the Navigation Team's ability to estimate the small forces. The desaturation times were provided by LMA on February 20, 1999. Also during the January 1999 to February 1999 time frame, the Navigation Team apprised the project staff that the small forces problem could affect OD accuracy. By February 11, 1999, a navigation analyst at JPL had manually manipulated the AMD format to produce a readable file. Results were faxed to LMA on March 12, 1999, showing the effect of a corrected AMD file on the two-way Doppler data. On April 6, 1999, a Failure Report (FR) was written at LMA describing the file issues. On April 19, 1999, the file was verified as corrected at LMA. An e-mail from Navigation on April 26, 1999, verified that the format was readable. In fact only the format issue had been resolved. The units error was still present and unrecognized.

Figure 13 outlines the format error.

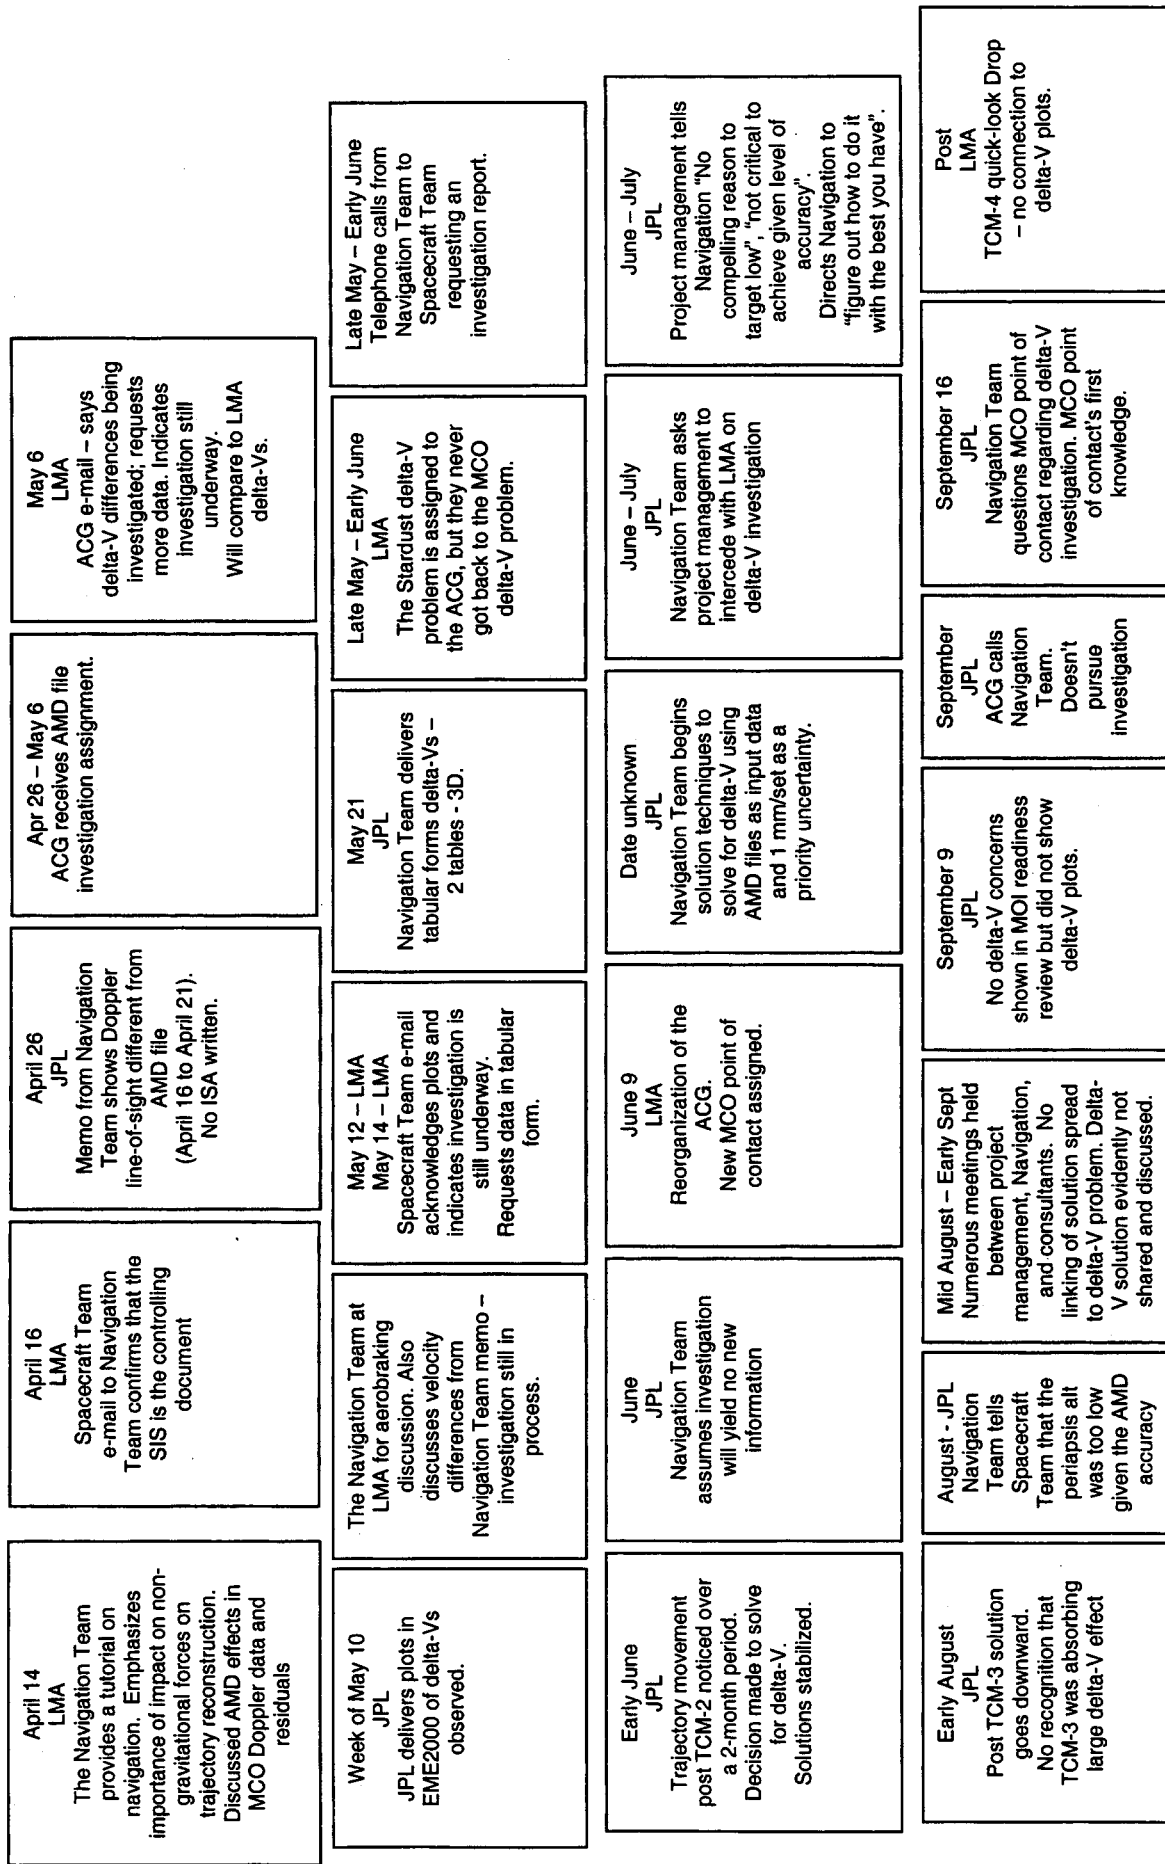
Figure 14: Chronology of the Desaturation Delta-V Anomaly

After the meeting, an inquiry was made regarding progress on the AMD velocity problem. It was determined that there was none. There was still no connection made between the results of the maneuver, the scatter in the orbit solutions, and the AMD problem.

Figure 14 illustrated the chronology of the desaturation delta-V anomaly.
